# Solving a High RSSI Issue with InterferenceAdvisor™

Improper installation of a service antenna caused high RSSI problems, affecting LTE services.

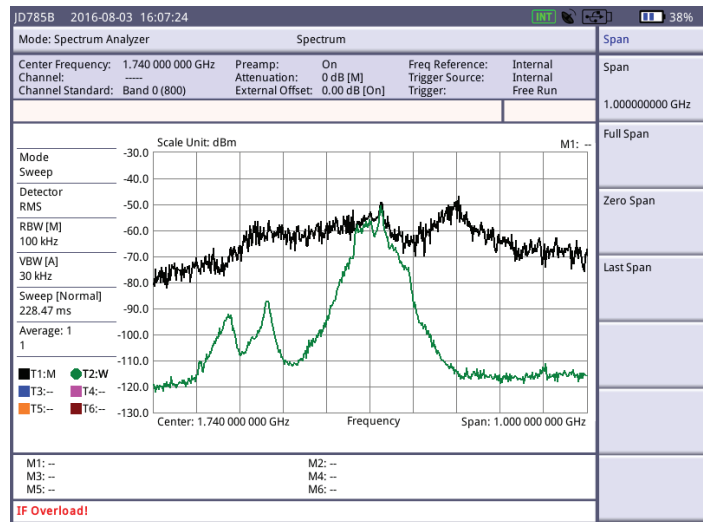
High noise floor across the spectrum

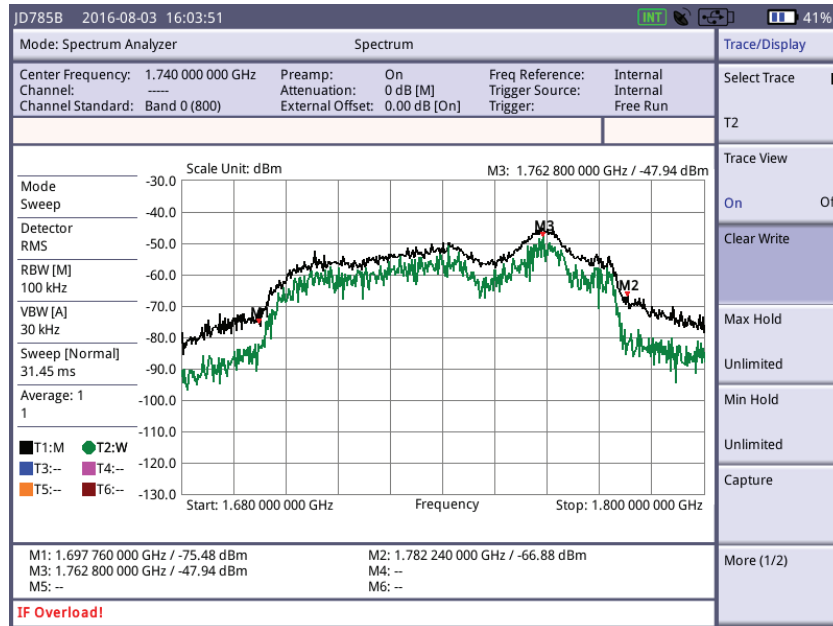
The service provider reached out to Viavi to see if InterferenceAdvisor would be the right solution for locating the interference. While driving the problem area, the team observed a high noise floor spread across 150MHz.

Noise floor goes up across the spectrum, affecting LTE services

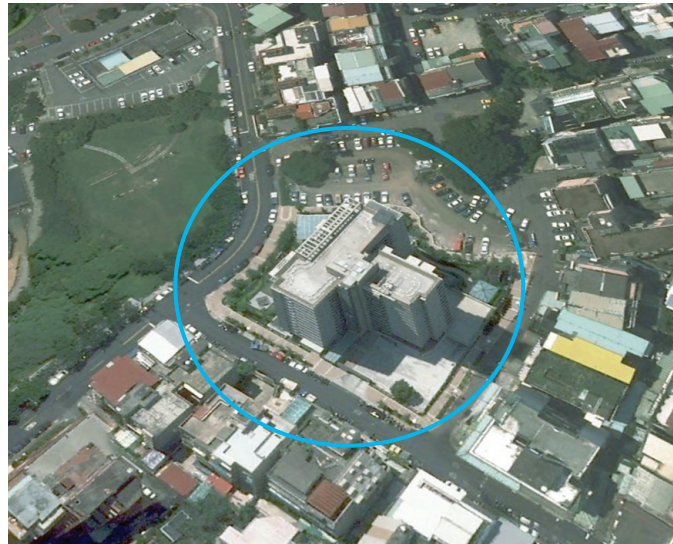
The team then conducted a local interference hunt, using Viavi CellAdvisor™ and AntennaAdvisor. The strongest signal was coming from a luxury apartment building, where the team successfully located the interference source on the ground floor.

The source of the interference was quickly identified as a repeater service antenna installed on the first floor. As soon as the antenna was removed from service, the interference issue was resolved.

The strongest signal was coming from a luxury apartment building.

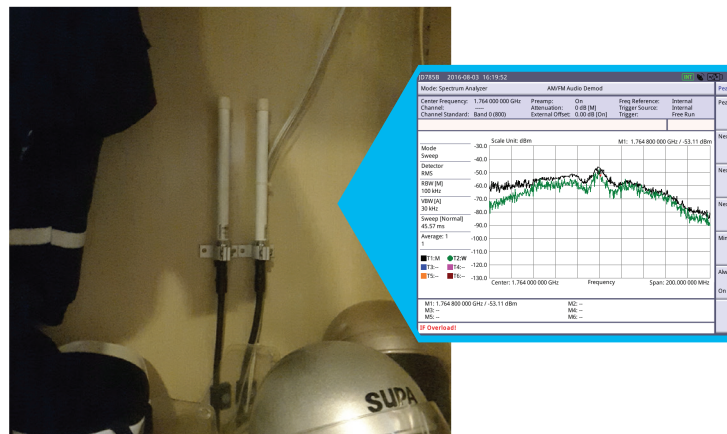
The interference source: a repeater antenna on the first floor.
